Effect of precast-prestressed flooring systems on the seismic performance of reinforced concrete frames

B.H.H. Peng, R.P. Dhakal & R.C. Fenwick
University of Canterbury, Christchurch, New Zealand

ABSTRACT: A one story, two bays, approximately half scaled, perimeter moment frame containing precast-prestressed floor units was built and tested at the University of Canterbury to investigate the effect of precast-prestressed floor units on the seismic performance of reinforced concrete moment resisting frame. This paper gives an overview of the experimental set up and summarizes the results obtained from the test. The results show that elongation in the beam plastic hinges is partially restrained by the prestressed floor, which increases the strength of the beams much more than that being specified in the codes around the world.

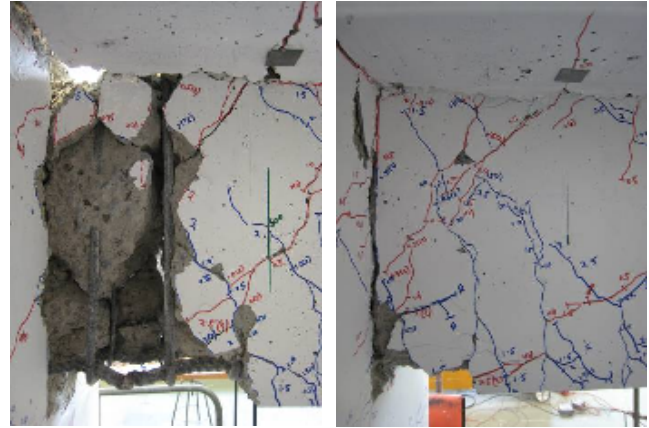
Figure 5. Damage to the sub-assembly at the end of test.

(a) Damage in the exterior and interior plastic hinges.

(b) Damage in the prestressed floor connection next to the exterior and interior plastic hinges.

(c) Damage under-nest the floor next to the exterior and interior plastic hinges.

Photographs of the key damage sustained till the end of the test are shown in Figure 5 and Figure 6. Flexural cracking first appeared in the longitudinal beams and the floor slabs at 0.25% drift. Minor cracking in the columns and prestressed floor connections appeared at 0.35% drift. At 0.5% drift, diagonal cracks appeared in the longitudinal beams and the slabs. First sign of yielding occurred at 0.75% drift. At 1.0% drift, torsional cracks developed in the transverse beams. The differential movement between slabs and beams became apparent at 1.5% drift. Spalling occurred in the exterior plastic hinges at 2.0% drift. At 2.5% drift, spalling occurred underneath the floor starter bars. The exterior plastic hinges lost concrete cover exposing buckling of bottom reinforcement at 3.0% drift and the bottom bars in the plastic hinge next to Column A fractured at 3.5% drift. All the bottom reinforcement in the exterior plastic hinges fractured under low cycle fatigue at 4.5% drift and the test was terminated at this stage.

It can be seen from Figure 5 that the region around the exterior plastic hinges sustained more damage than the region around the interior plastic hinges. Severe concrete spalling, reinforcement buckling and bar fracture were observed in the exterior plastic hinges whereas the interior plastic hinges only sustained minor spalling and minor bars buckling. This difference may be attributed partially to the participation of the floor slabs acting as deep beam as shown in Figure 8, which provides additional strength and stiffness to the interior plastic hinges. The difference in the anchorage conditions between the interior and exterior beam-column joints would also affect the deterioration of the plastic hinges.

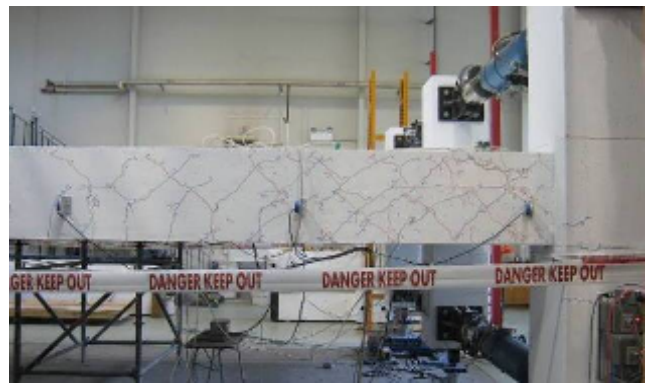
Figure 6. Torsional cracks in the transverse beam at the end of test.
